# HIGHWAY RESEARCH **RECORD**

327

Pavement Rehabilitation  
and Design of Overlays

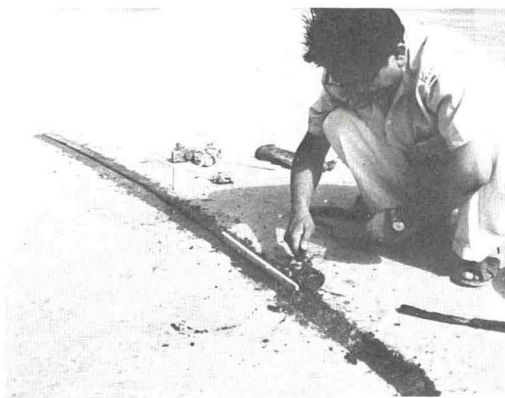
Figure 1. Preparation of central groove in the freshly laid resin sand mortar along a crack under repair on National Highway 2.
